**Flood Control Project Maintenance
Levee Inspections**

Fall 2009 Levee Maintenance Deficiency Summary Report

San Joaquin River Basin

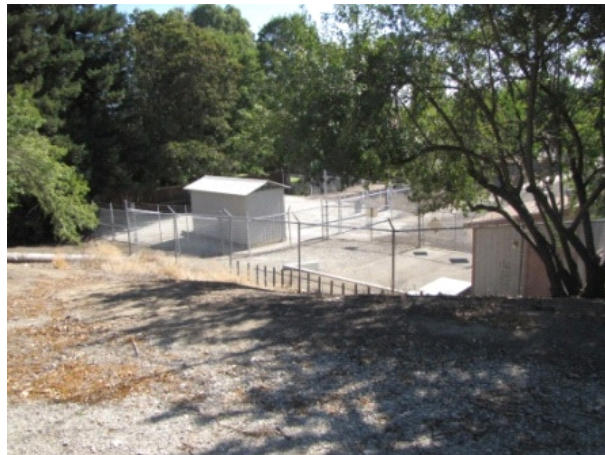
Levee Mile Report Line	147
Start Levee Mile	22.87
End Levee Mile	22.89
Location	Land Side
Category	Earthen Levee
Item	Encroachments

View of fence along the landward slope.

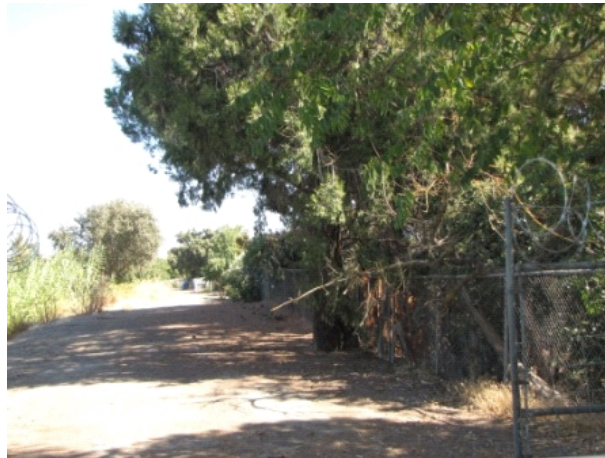
dpesaven_20091026_176.jpg

View of fence and landscaping along the landward shoulder looking upstream.

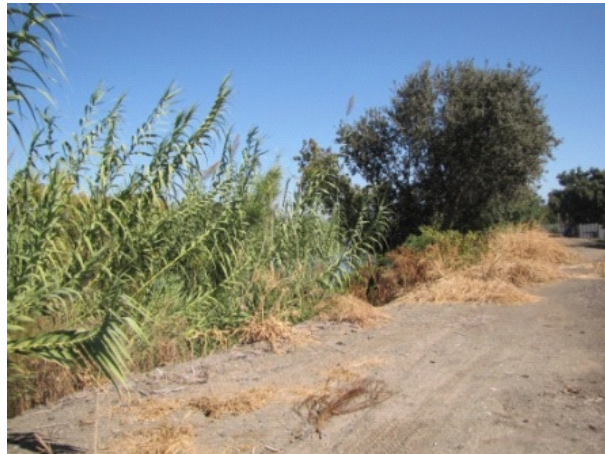
Levee Mile Report Line	150
Start Levee Mile	22.99
End Levee Mile	23.06
Location	Water Side
Category	Earthen Levee
Item	Vegetation

View of excessive vegetation along the waterward slope blocking visibility and access looking upstream.

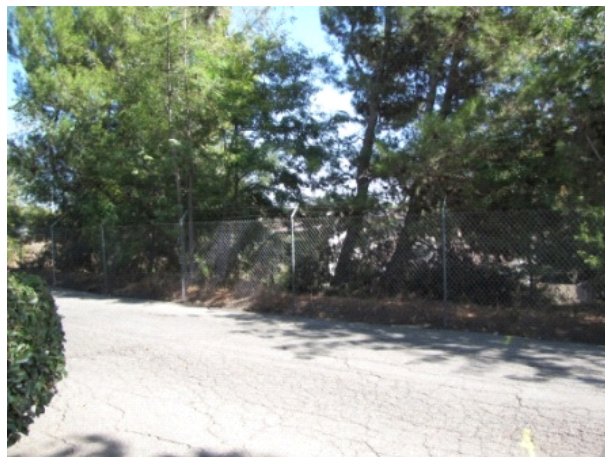
Levee Mile Report Line	152
Start Levee Mile	23.08
End Levee Mile	23.22
Location	Land Side
Category	Earthen Levee
Item	Encroachments

View of fence along the landward shoulder looking upstream.

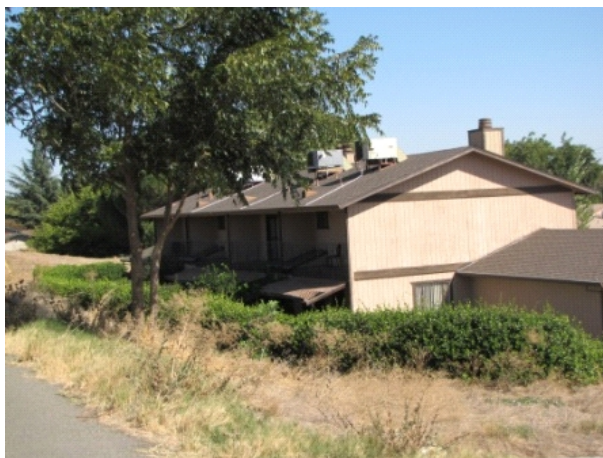
dpesaven_20091026_174.jpg

View of landscaping along the landward slope looking upstream.

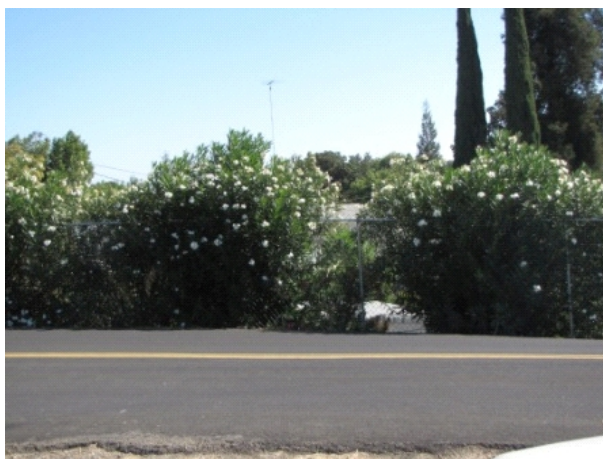
Levee Mile Report Line	155
Start Levee Mile	23.30
End Levee Mile	23.34
Location	Land Side
Category	Earthen Levee
Item	Encroachments

View of fence and landscaping along the landward slope.

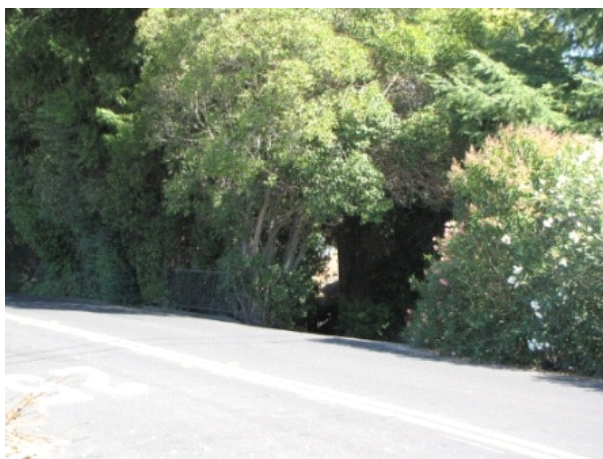
Levee Mile Report Line	156
Start Levee Mile	23.30
End Levee Mile	23.34
Location	Land Side
Category	Earthen Levee
Item	Encroachments

View of landscaping along the landward levee slope looking upstream.

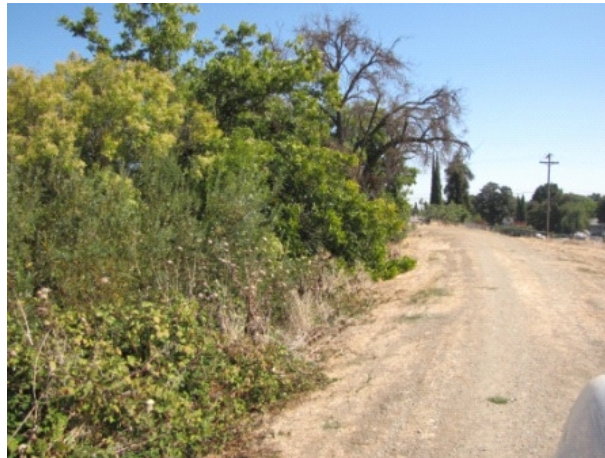
dpesaven_20091026_171.jpg

View of excessive vegetation along the waterward side of levee obstructing visibility and access looking upstream.

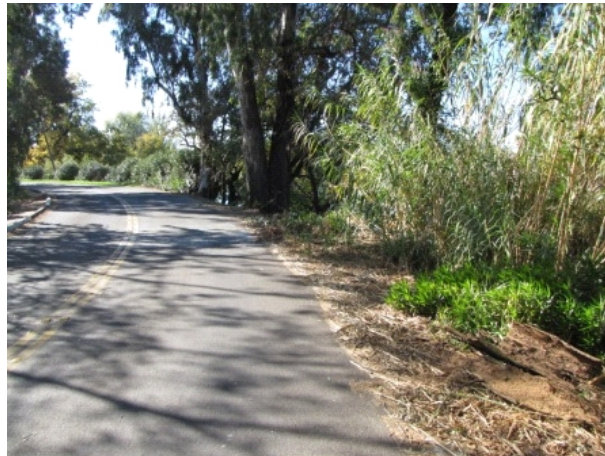
dpesaven_20091124_528.jpg

Levee Mile Report Line	158
Start Levee Mile	23.70
End Levee Mile	24.00
Location	Water Side
Category	Earthen Levee
Item	Vegetation

View of the vegetation on the waterward slope looking downstream.

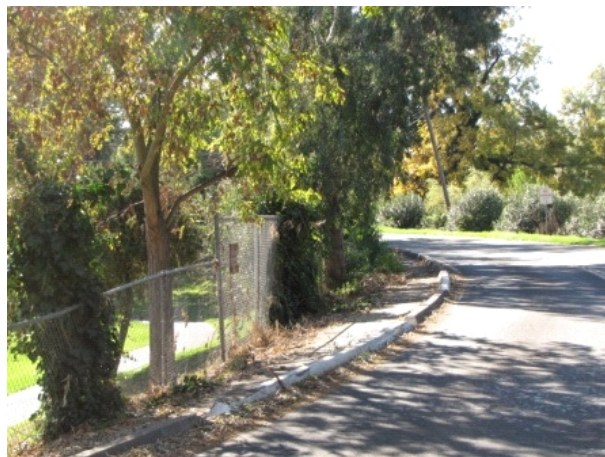
dpesaven_20091124_529.jpg

Levee Mile Report Line	159
Start Levee Mile	23.70
End Levee Mile	24.00
Location	Land Side
Category	Earthen Levee
Item	Vegetation

View of the vegetation along the landward slope looking downstream.

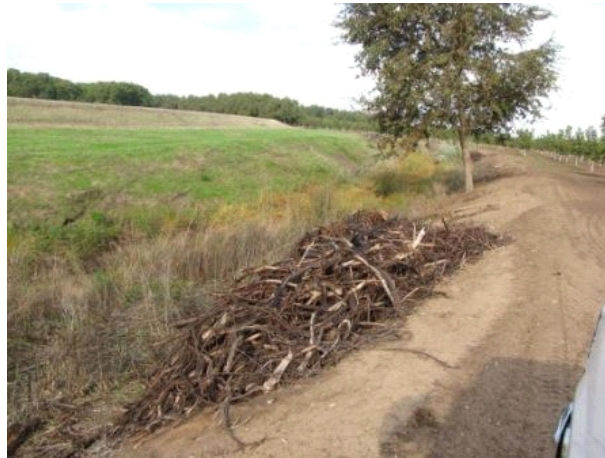
dpesaven_20091028_293.jpg

View of a prunings pile along the waterward bank looking downstream.

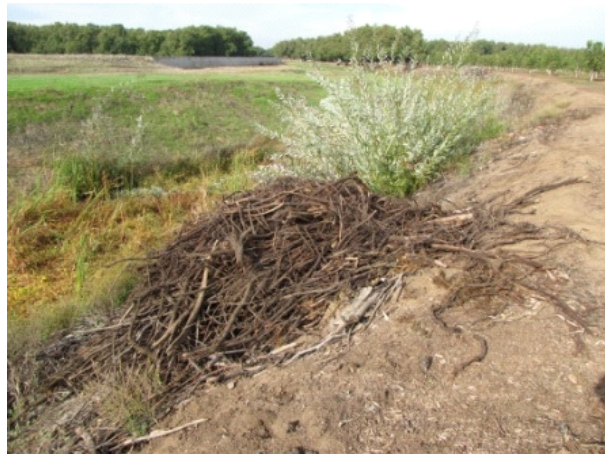
dpesaven_20091028_294.jpg

Levee Mile Report Line	2
Start Levee Mile	0.17
End Levee Mile	0.17
Location	Water Side
Category	Earthen Levee
Item	Encroachments

View of a prunings pile along the waterward bank looking downstream.

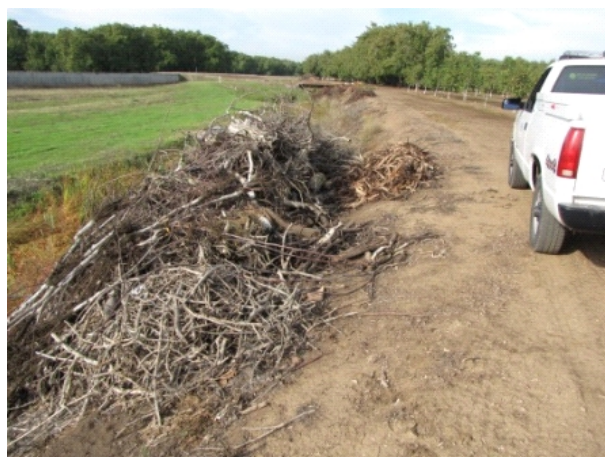
dpesaven_20091028_295.jpg

Levee Mile Report Line	3
Start Levee Mile	0.22
End Levee Mile	0.22
Location	Water Side
Category	Earthen Levee
Item	Encroachments

View of a prunings pile along the waterward bank looking downstream.

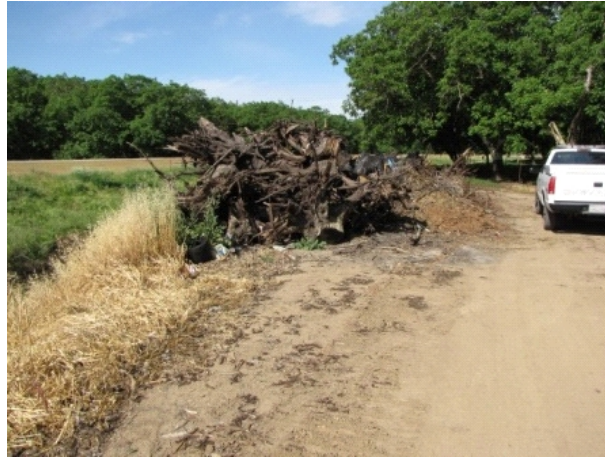
Levee Mile Report Line	6
Start Levee Mile	0.37
End Levee Mile	0.37
Location	Water Side
Category	Earthen Levee
Item	Encroachments
Debris pile located on waterside of levee at LM 0.50.	
dpesaven_20091002_28.jpg

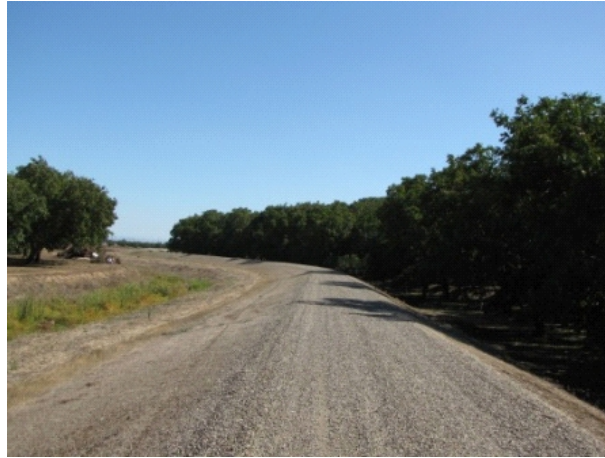
dpesaven_20091026_220.jpg

Example view of the good vegetation and maintenance practices along this unit.
